Evaluation of Consolidation Treatments for the San José Convento Column, San Antonio Missions National Historic Park, San Antonio, Texas

A THESIS

MASTER OF SCIENCE IN HISTORIC PRESERVATION

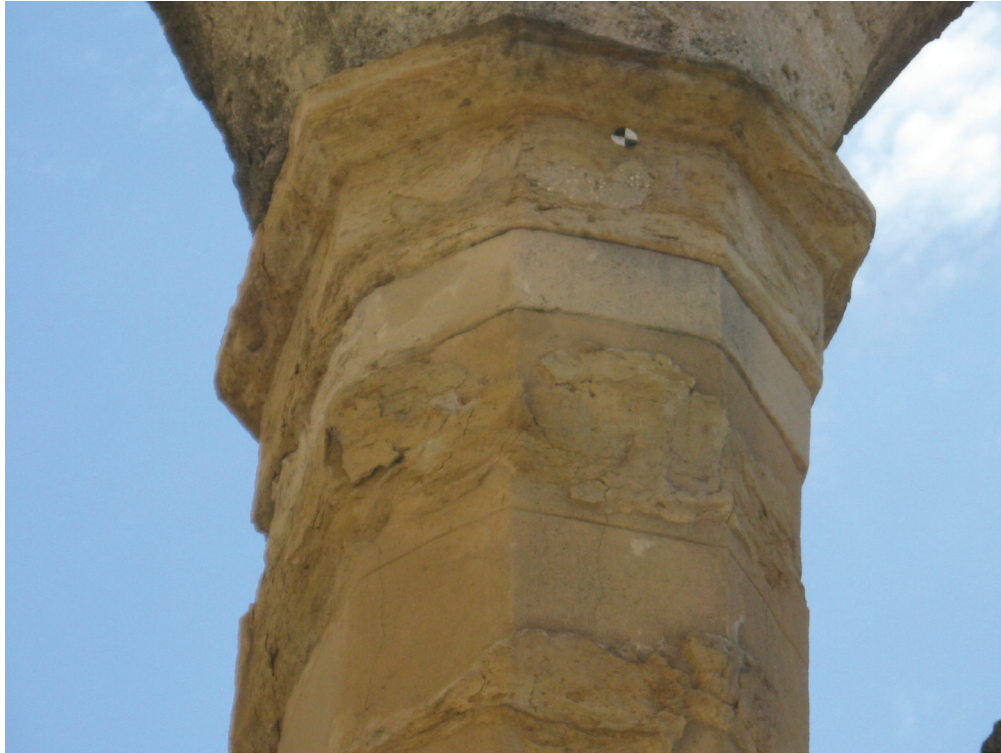
Figure 1.1 Microcracking seen during 2011 Assessment

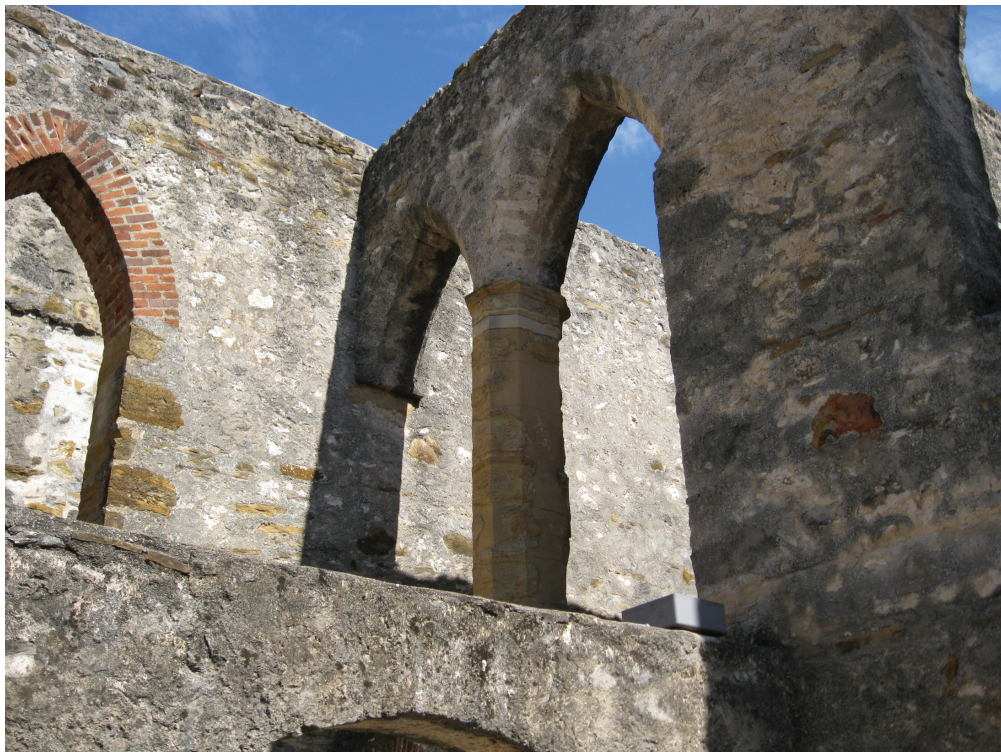
Figure 1.2 San José Convento Column, 2011.

The San José Convento column is constructed out of a locally impure limestone and laid with a gypsum-lime bedding mortar.¹ The entire column is composed of nine limestone drums that reach a height of 7 ft 10 in. The first seven drums form the shaft of the column and are carved out of a golden-brown fine-grained limestone. The eighth drum forms the necking of the column and is made of a grey fine-grained limestone while the capitol is carved from a golden brown limestone.² Originally intended to be an interior feature, the column has been exposed to the outdoor conditions for the last 150 years. During the column's early history, it was periodically exposed to cyclical moisture, causing the soluble gypsum in the mortar to dissolve, infiltrate the impure limestone, and recrystallize during evaporation, further spreading sulphate salts throughout surrounding column's masonry and especially along the drum joints. Historic photographs of the column highlight the progressive deterioration of the stone and the subsequent mortar repair treatments. The first treatments to the column are visible in a 1927 photograph and have been identified as gypsum mortar infills of deteriorated and presumably lost or removed stone (Karas 2011). Further mortar repairs were performed during the 1960s and were composed of lime and sand (Brackin 1993, 99). The deterioration of the column became a primary concern following the creation of San Antonio Missions Historical National Park in 1978. In 1987, the deterioration of the column was further monitored and a treatment program was initiated in 1993.

The findings indicated that the north elevation of the column displayed the highest level of deterioration with areas of detachment and micro-cracking. Cracks visible in the 1994 image expanded in width and length. Composite repairs on the east elevation are cracked. Cracking was also present on the south and west elevations. SEM analysis suggested that in certain areas the treatments behaved as a mixture after application as the ethyl silicate had reacted preferentially with the MTMOS, which may have reduced bonding to the stone. SEM analysis of the original untreated stone verified the 1993 compositional characterization and highlighted the abundance of clays within the argillaceous limestone.⁶

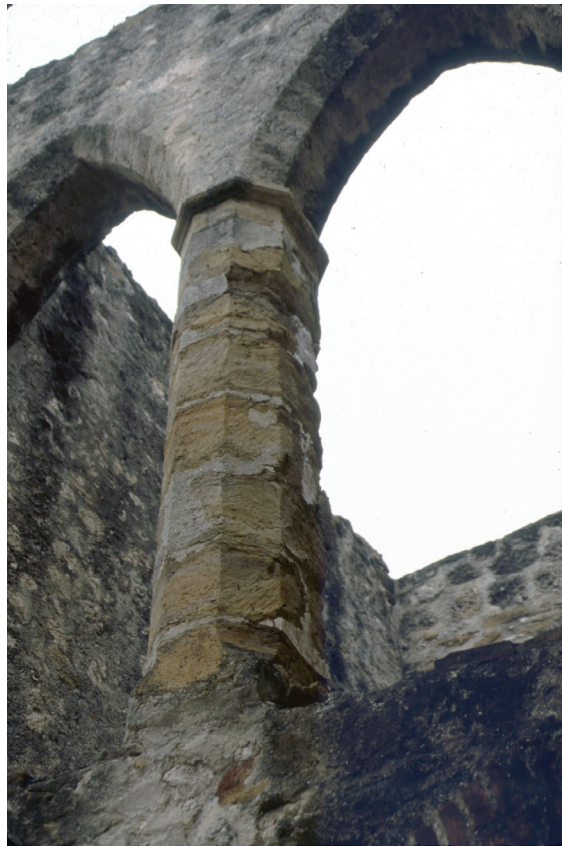
Figure 1.3 Convento Column prior to 1993 Treatment

The bedding and repair mortar were determined to contain high amounts of calcium sulfate dihydrate ($\text{CaSO}_4 \cdot \text{H}_2\text{O}$), or gypsum. The active deterioration mechanism was determined to be the dissolution and recrystallization of the water-soluble gypsum binder in the mortar and the infiltration of this material into the stone. The recrystallization of this mineral would exert pressure on the walls of the pores and eventually cause cracking and delamination. The swelling of the inherent clays within the limestone was also determined to be a contributing factor to the deterioration, which were believed to swell during exposure to exterior conditions and would exert further pressure within the stone pores. These processes affected the stone by causing excessive surface friability and delamination of larger fragments of the stone.

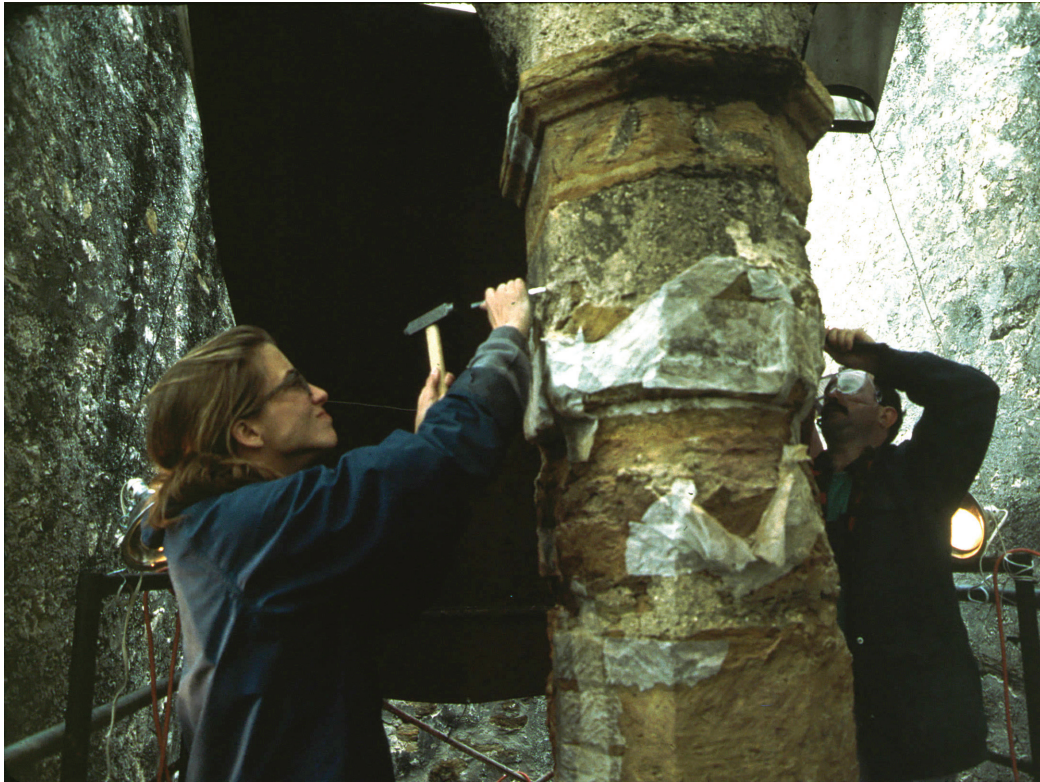
Figure 1.4 Phase 1 of 1993 Treatment (ACL 1993)

Phase 1 dealt primarily with the preconsolidation of the column to prevent further loss of material during subsequent treatments. During this phase, the column was extensively documented, and previous repairs and patches were removed.

Gypsum bedding mortar was removed as far back as possible.

A 7.5-15% solution of Acryloid B72 was applied in a 1:1 mixture of xylenes and toluene with Japanese tissue paper to temporarily protect fragile areas. Fine cracks were injected with a 15% solution of B72 while remaining friable areas were applied with a solution ranging from 3.75-7.5%. Blind voids in association with removal of the previous repairs were injected with a grout consisting of 2: 1:1:1.5 (by volume) of a moderately hydraulic lime (Riverton Corp), microballoons (Zee-lite spheres, Zeelan Industries), fine silica sand (passing #30 sieve), and water. Three separate poultices consisting of a mixture of $\frac{1}{2}$ rag stuff paper pulp and 3% glycerin were then applied in an attempt to remove residual gypsum salts.

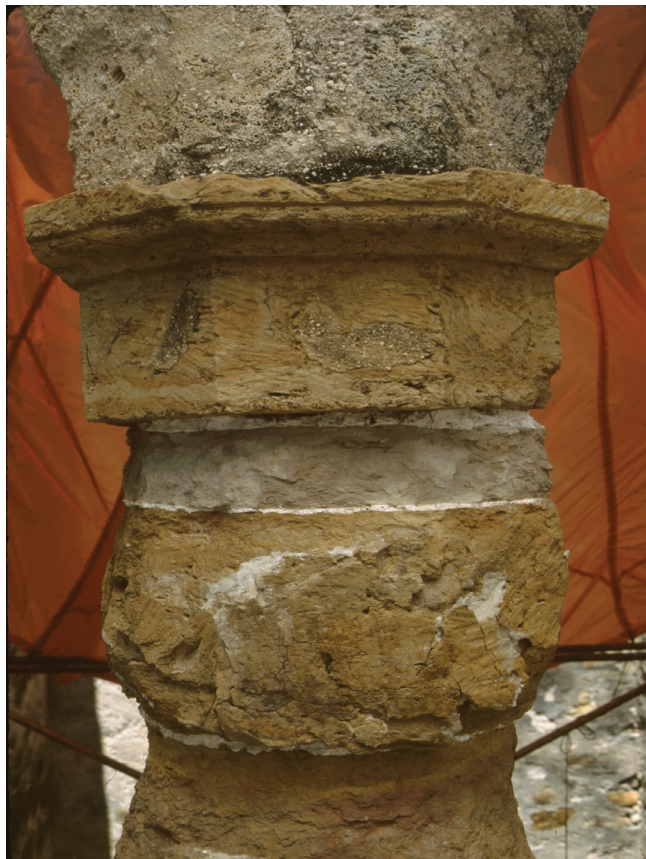
Figure 1.5 Column following consolidation and prior to patching (ACL 1993).

Large flakes were reattached using a 15% B72 solution and large cracks were injected with a 1:1 mixture of 15% B72 and microballoons. Exposed surfaces of the original stone after patch removal were tooth-chiseled to expose sound stone

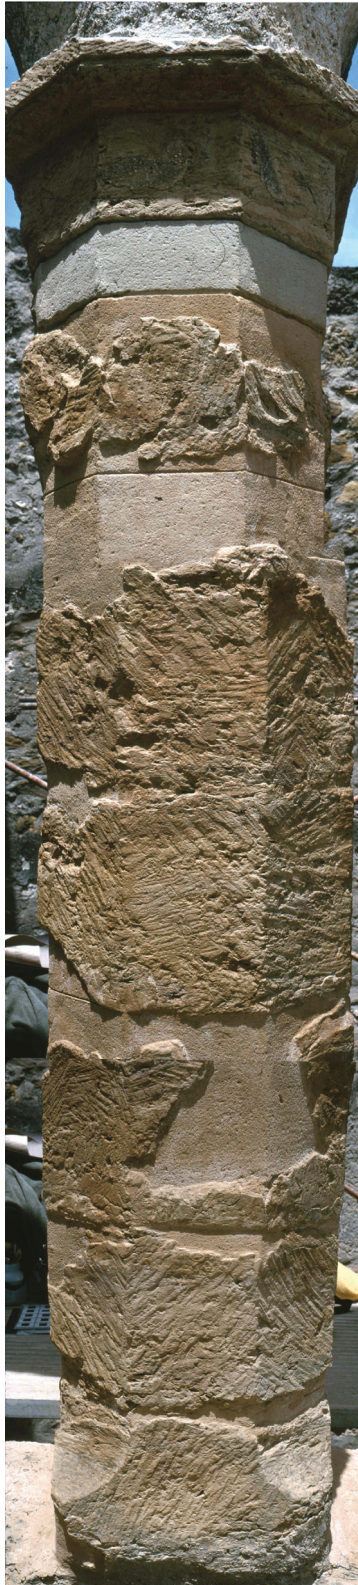
Figure 1.6 Column Following Treatment in 1994 (ACL 1994)

Following a cure time of one month, the patches were roughened and brushed to remove laitance. The stone was then further drilled in still hollow-sounding areas and injected with a 15% solution of B72 and microballoons. After drying for 32 hours, the column was brushed with 32 ounces of methyltrimethoxysilane (Dow-Corning Z-6070) to impart water repellency. Following the completion of the conservation program, a preventative maintenance and monitoring program was established that recommended annual permeability measurements be performed using a RILEM test for water absorption (11.4) and the reapplication of the water repellent every 5 years or as needed based on the measurements.⁴

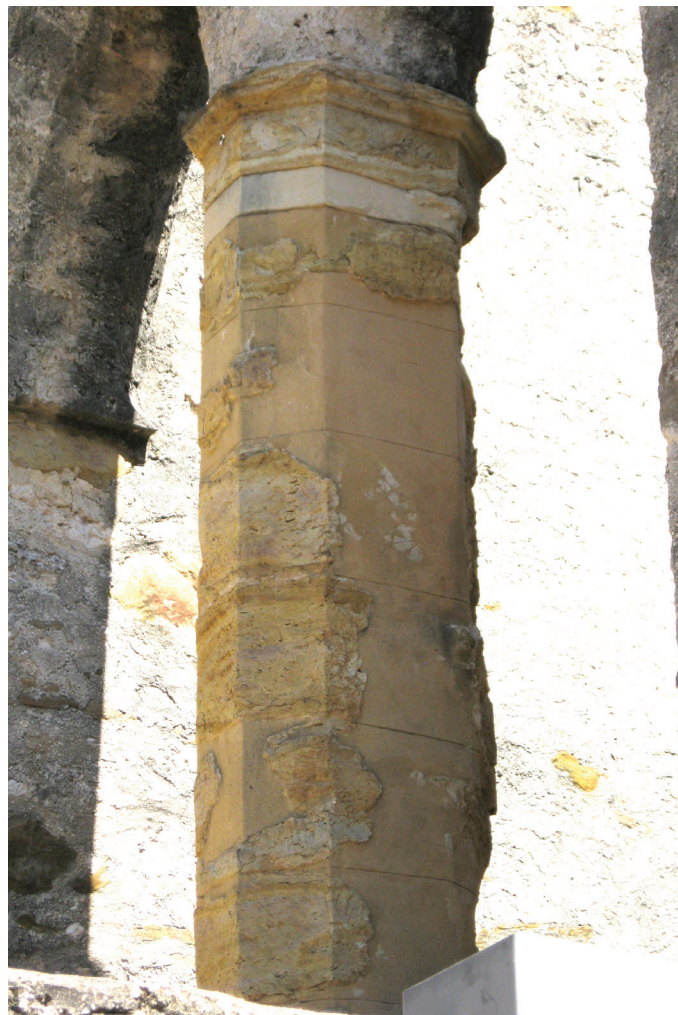
Figure 1.7 San Antonio Column in 2011 (Youngborg 2011)

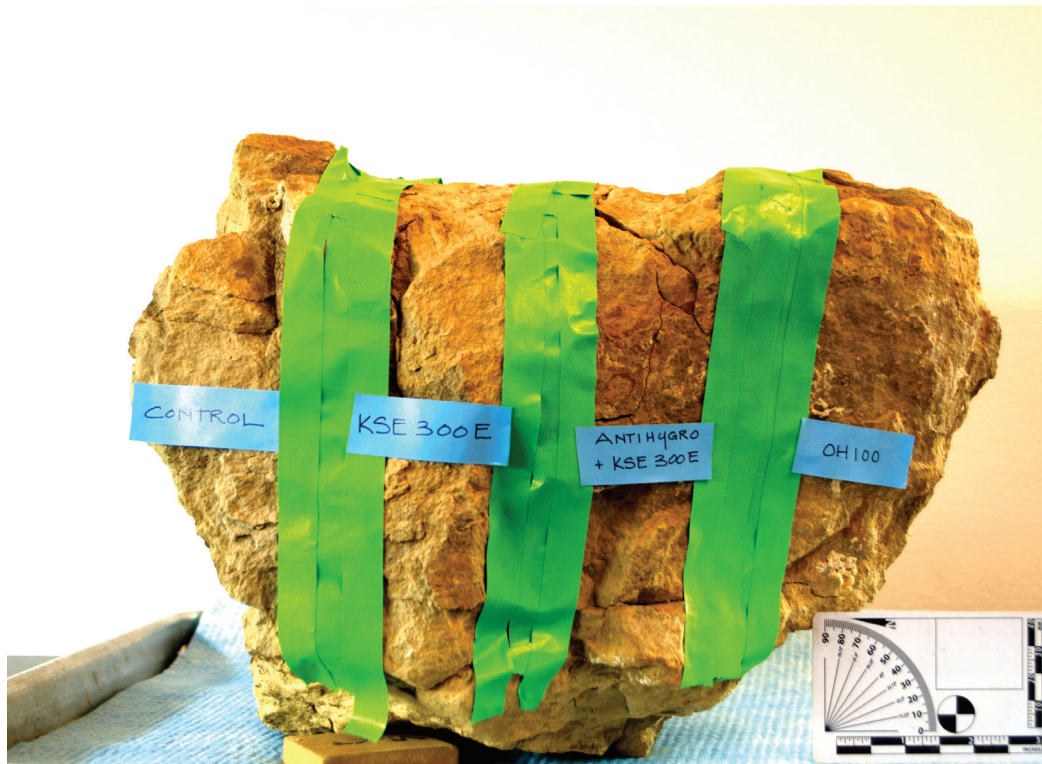
Figure 4.3 Boulder Sample E Prior to Treatment

Samples were then divided into their respective cohorts comprised of seven 2" cubes and three 0.5" x 10" square coupon . A total of four cohorts (control, Conservare® OH100, KSE 300 E, and Funcosil® Antihygro® + KSE 300 E) were identified with twenty-eight 2" cubes and twelve 0.5" coupons. All stones were labeled on all faces with a marker to denote cohort (letter), sample within cohort (number), and face of sample (number).

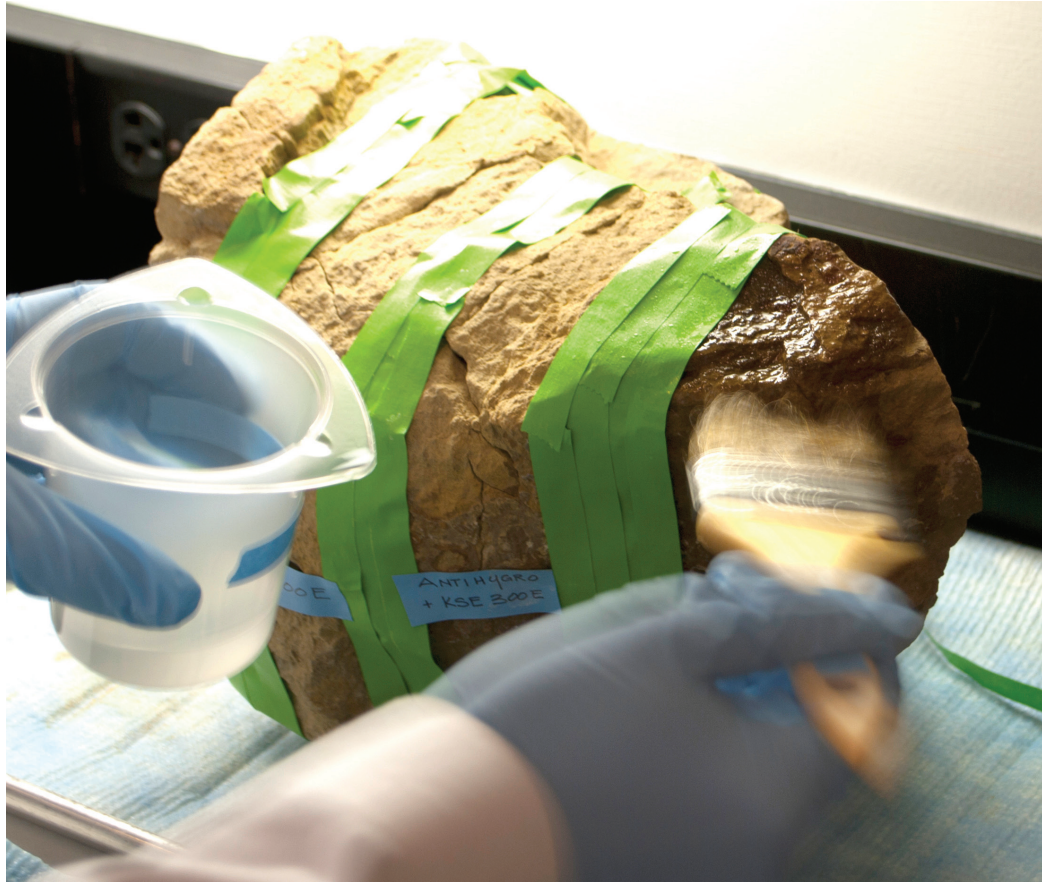
Figure 4.5 Application of Consolidant to Boulder

Following application, the sample surface was flashed with methyl ethyl ketone as recommended by the manufacturer and an absorbent pad was used to

remove excess consolidant and avoid a change of color and a change in the surface texture caused by cured consolidant on the surface of the stone.

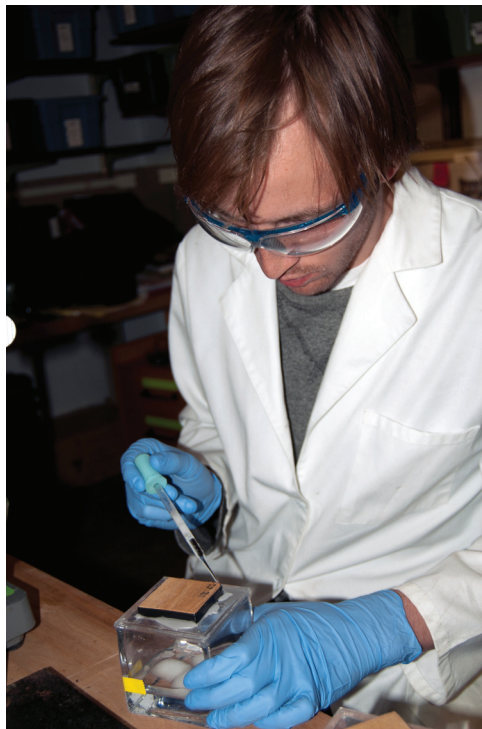
Figure 5.1 Test Dish Construction

The test dish was filled with approximately 50mL of distilled water. Cotton balls were placed within the container to reduce condensation within the sealed container, which could theoretically alter water vapor transmission rates. Samples were wrapped three times in Scotch Super 33+ $\frac{3}{4}$ inch electrical tape to seal the edges of the sample and prevent transmission of vapor through the sides of the samples. The samples were then placed on the top of the container. Heated paraffin wax was applied with a Pasteur pipette to hold the sample and hermetically seal the

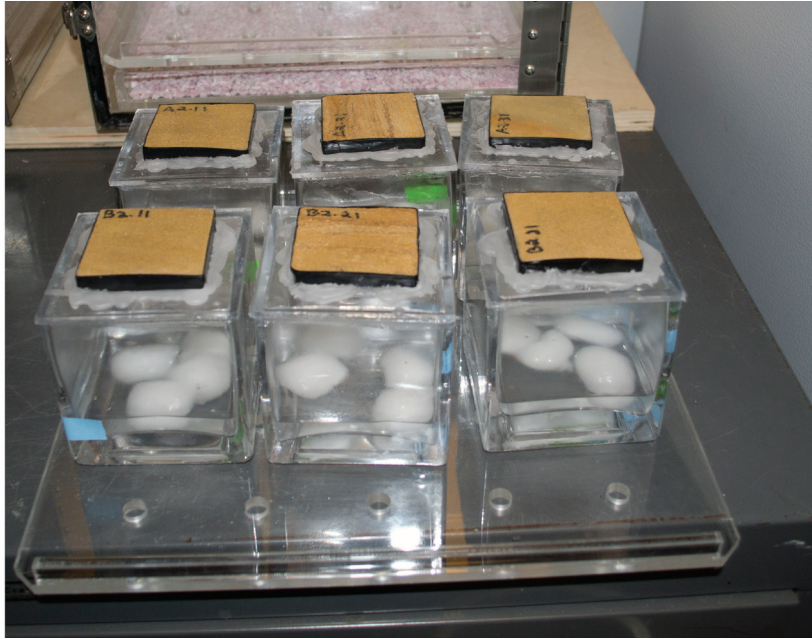
Figure 5.2 Assembled Cubes ready for testing

edges of each specimen in order to create an appropriate assembly for the test.

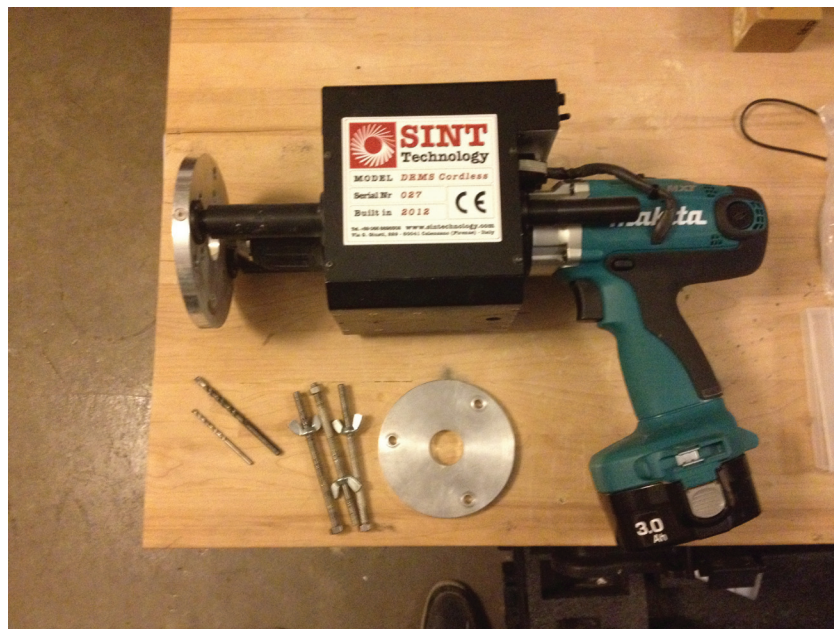
Figure 5.4 DRMS Cordless System produced by SINT Technology with drill bits and attachments

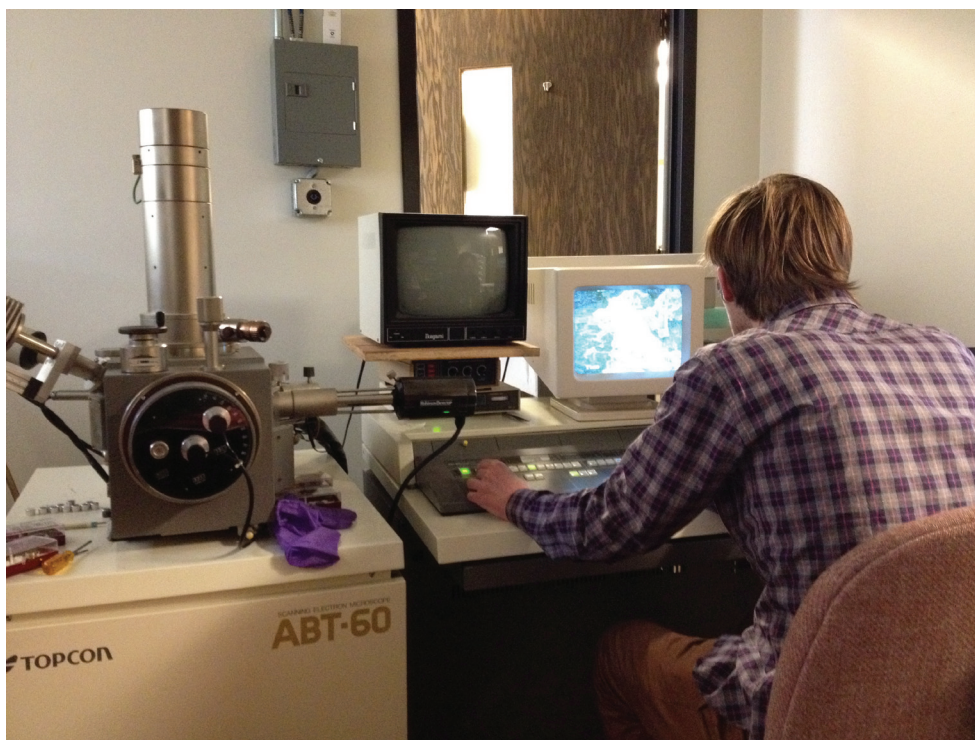
Figure 5.5 K. McNabb operating opcon ABT-60 scanning electron microscope

The backscatter image helps produce a “topographic” image of the sample. Through the use of the detector within the SEM, additional images can be created using the backscatter and secondary electrons. Secondary electron images (SEI) were captured with Bruker Esprit 1.8 software. On this imaging software, the brighter spots produced on the backscatter image illustrate the heavier elements while the dark spots display areas of little information and lighter elements. When understanding the relationship between voltage and spot size on the sample, the highest voltage uses the smallest spot size. Samples that are not excellent conductors require the initial use of lower voltages progressing slowly to higher voltages.
